### ARCHITECTURAL REVIEW BOARD

#### AGENDA

April 23, 2024 – 5:30 p.m. Council Auditorium, City Hall (103 North Perry Street)

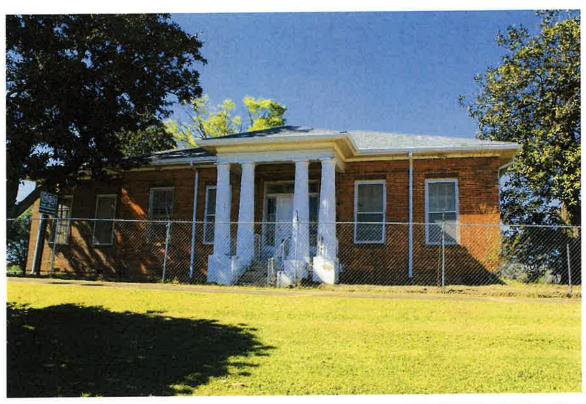
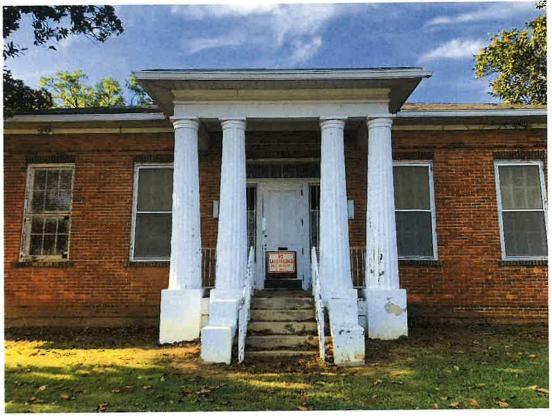
1020 Maxwell Boulevard (Individual Designation), south façade context and detail, 03/28/24,  $04/04/24\,$

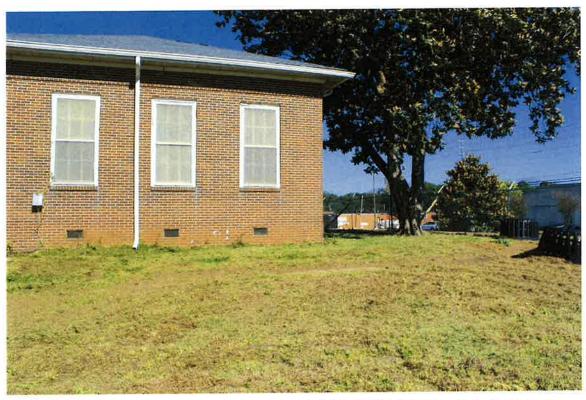
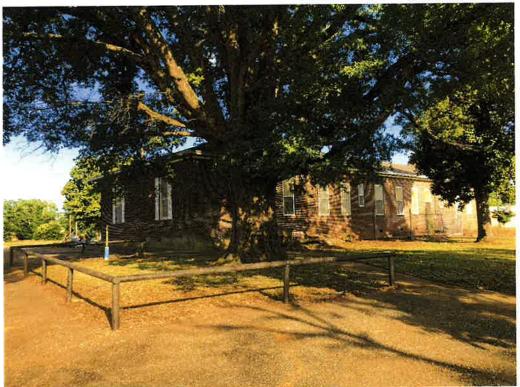
1020 Maxwell Boulevard (Individual Designation), detail of west elevation window to be altered to install an entry door, deck, and egress stairs, and new driveway area at northwest, 04/04/24

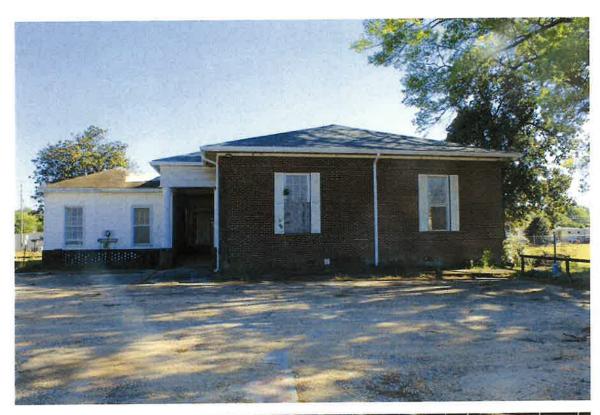
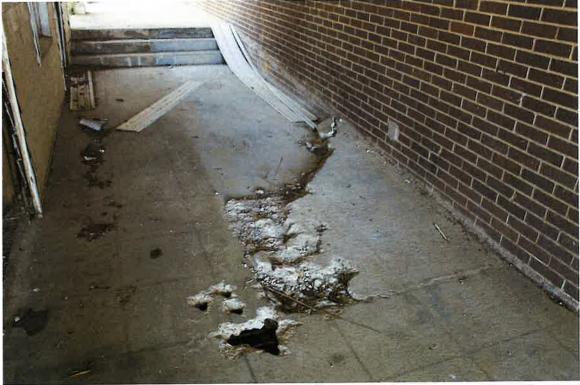
1020 Maxwell Boulevard (Individual Designation), north (rear) elevation and detail of walkway between main building and outbuilding to be demolished and rebuilt in concrete, 04/04/24

(vi.) The proposed demolition covers the entire outbuilding, down to its foundations but with the foundation wall remaining in place for new construction. The existing concrete slab at southeast part of the building will be removed. The walkway and ramp between the outbuilding and main building will also be demolished and rebuilt in concrete, as described in (i.). A brick retaining wall, a portion of projecting roof overhang, and two columns on the north elevation, adjacent to the outbuilding, will be removed. (vii.) The outbuilding will be newly constructed with James Hardie cementitious smooth face siding and trim, white in color. Existing windows on the north elevation will be put back in their original place while windows on the east elevation will be reused and have PVC or painted wood shutters added. New windows clad in vinyl or aluminum will be installed on the south elevation. The outbuilding will have a new hipped roof clad in asphalt shingles that will be reconfigured as subordinate to that of the main building while the conjoining section of new roof on the main building will run in a seamless line from the northeast corner, southward, to a point above the replacement walkway.

- No objection: staff recommend approval of all items.
- Since the outbuilding is not original to the residence but rather a later addition and it is in fair to poor condition, staff support its demolition and the proposed new construction that is designed sensitively in relation to the original residence and overall historic site.

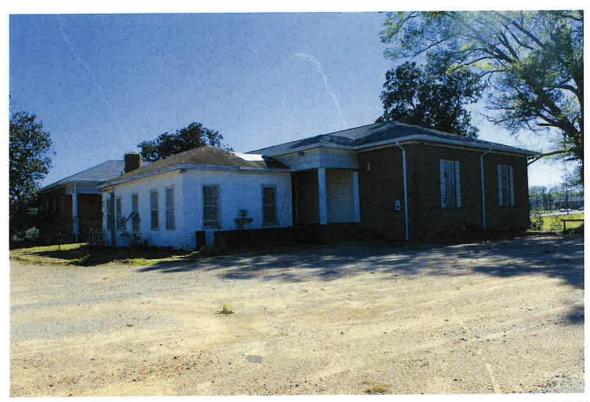
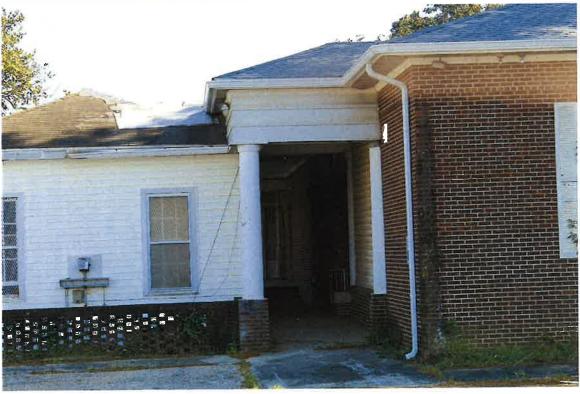
1020 Maxwell Boulevard (Individual Designation), and north and east elevations, and detail of walkway between main building and outbuilding, 04/04/24 and 04/05/24

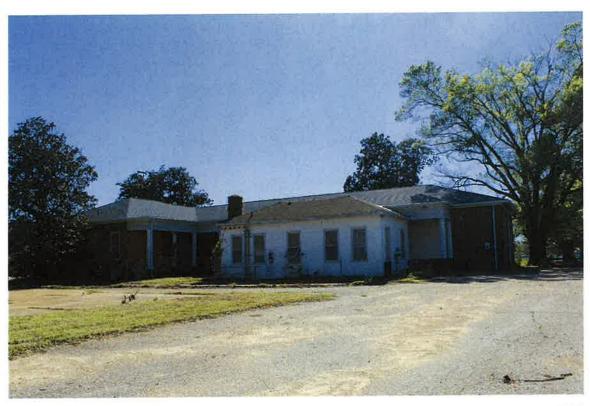
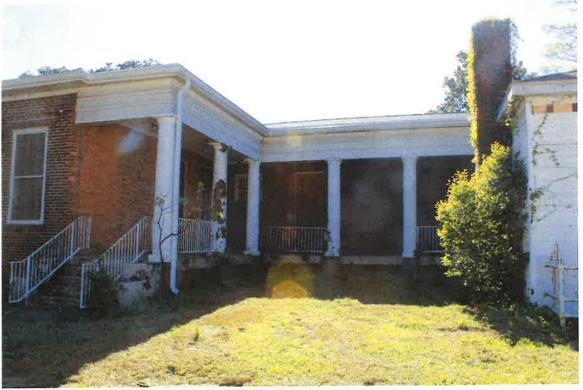
1020 Maxwell Boulevard (Individual Designation), east elevation, and detail of stair and walkway, 04/04/24

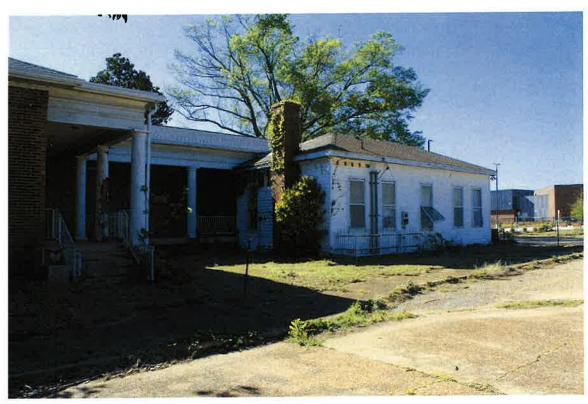
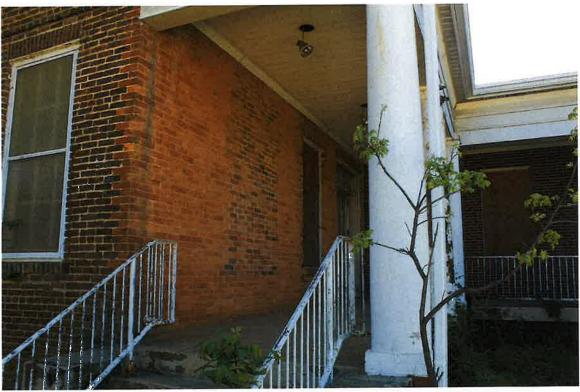
1020 Maxwell Boulevard (Individual Designation), east elevation, looking northwest, and detail of historic brick replacement or alteration, 04/04/24

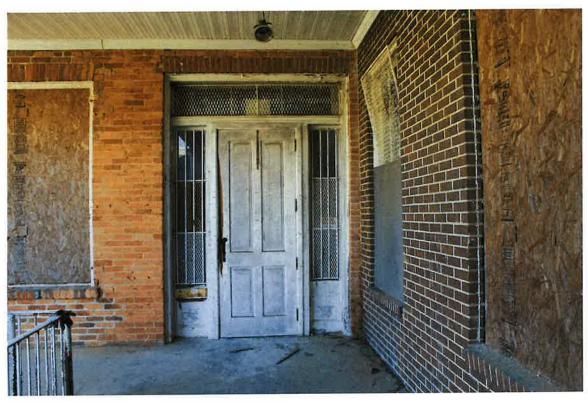
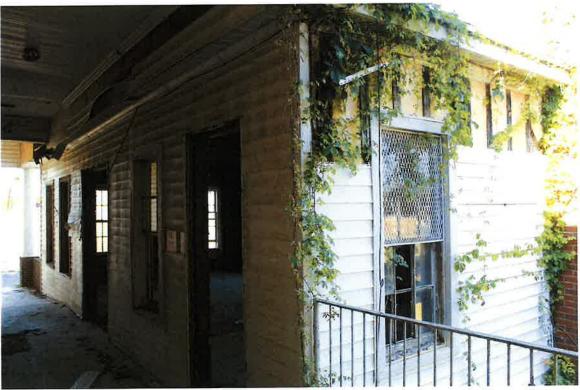
1020 Maxwell Boulevard (Individual Designation), detail of entry door to be repaired or replaced, and west elevation of the added outbuilding, 04/04/24

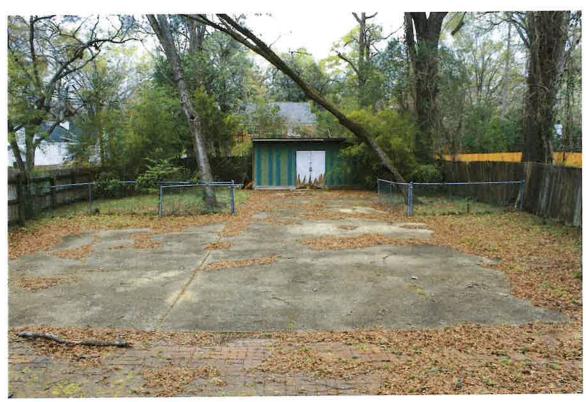
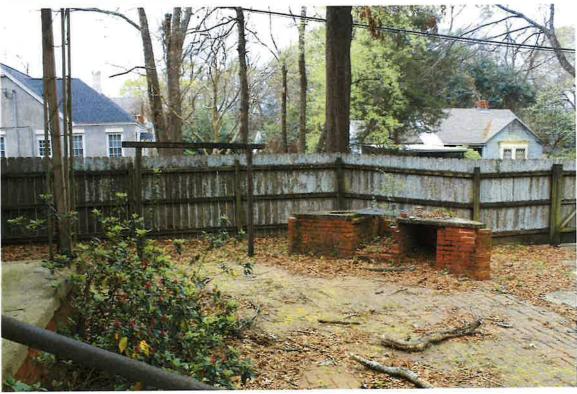
- (i.) The dilapidated outbuilding is currently situated in the rear yard, north of a concrete pad, and is partially caved in and therefore not cost effective to repair; also, the Warrens would like to replace the shed in a different location, as depicted on their site plans. (ii.) The new wooden tool shed would be located closer to the residence, just west of a brick patio and south of the concrete pad and would measure 12' x 16' and 8' tall. (iii.) There is a somewhat unusual chain link fence inside the rear yard that the petitioners would like to remove to improve circulation patterns. (iv.) Mr. and Mrs. Warren would like to set back two privacy fence sections: one on the west property line would be reconfigured to make space for their gravel parking pad and another on the north side of the property would be set back to the property line, giving them full use of their property. (v.) There is also another fence section on the east side of the residence that would be moved forward a few feet to meet a northeast corner of the home. (vi.) The gravel parking pad would be built on the west side of the property in the space created by moving that fence section back; it would measure 20' x 20' and be contained within their property boundary, as depicted in image 2C. (vii.) The petitioner would like to install four garden beds surrounding existing stone walkways and a 20' x 10' wood cedar pergola in the east side of the front yard. Finally, Mrs. Warren would like to build a chicken coop, measuring 6' x 10' and made of wood and wire, in the rear yard.

1201 Magnolia Curve, Old Cloverdale, current outbuilding, chain link fence, and location of new gravel parking pad and shed, 03/08/24

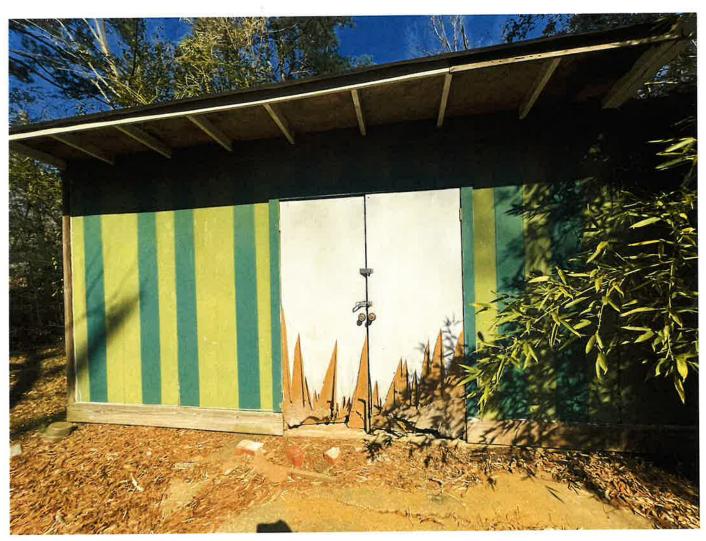
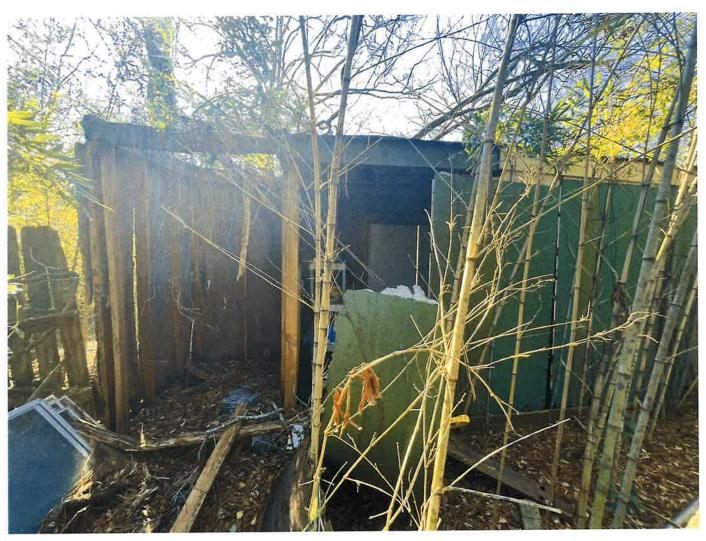
Shed for demolition

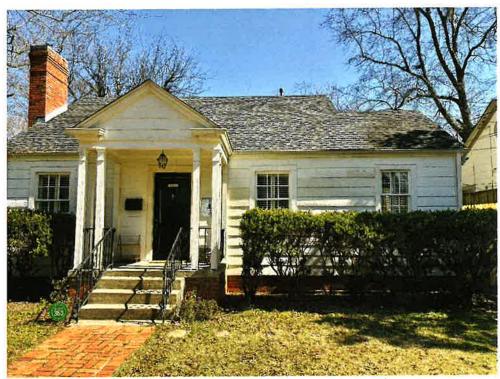
REMARKS: Ms. Luis is requesting permission to (i.) replace the current deteriorated vinyl or composite siding with cement board, AKA Hardie board siding, throughout the residence's exterior. There is water damage in several places on the current siding. The new Hardie boards (an example of which will be brought to the meeting) will be 12" wide with a 2" overlap, thereby keeping the same surface profile as what is there currently. Ms. Luis is also requesting permission to (ii.) replace the existing windows on the north, east, and south elevations with Jeld Wen-brand simulated divided lites in a composite material that will match the current divided lite pattern. A rehabilitation attempt will be made on the existing west façade windows along, accompanied by storm window installation; however, if this does not work, then the windows will be replaced inkind with true divided lites in a 6 over 6 pattern, matching the current windows. The petitioner is also requesting permission to (iii.) replace the current aluminum gutters with new, seamless aluminum gutters throughout the home. If feasible, there may be fewer gutters used than at present. Currently, there appears to be one horizontal gutter along the roof line on the west façade and two vertical downspouts on the north and south corners of the façade as well as another horizontal line and downspout on the south elevation in the rear of the home. Finally, Ms. Luis would like to (iv.) paint the residence using a partially non-palette color scheme: the main body would be medium green (dr-0784 or -0785), and trim would be Andover Cream. Color samples will be included in the agenda packet and brought to the meeting; also, these colors are very similar to ones on the pre-approved palette.

1. 1909 Graham Street - Front facade (west)

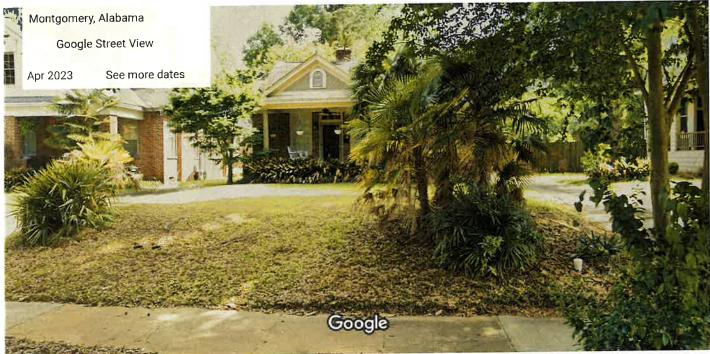
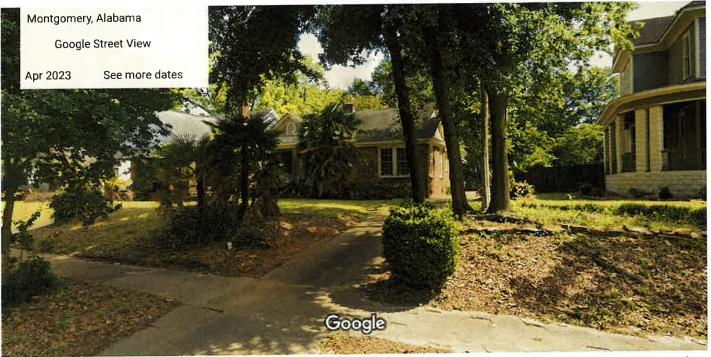
# Google Maps 1810 Madison Ave Workig had red brill

# 1810 Madison Ave Woriginal Ted Brick

• Staff recommend denial because paint on previously unpainted brick is not consistent with our design guidelines, and it creates an ongoing need for maintenance.

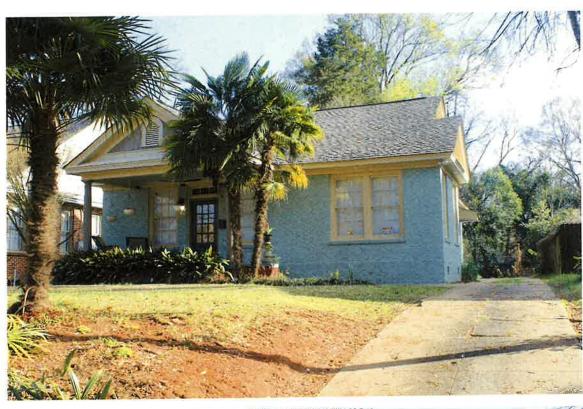
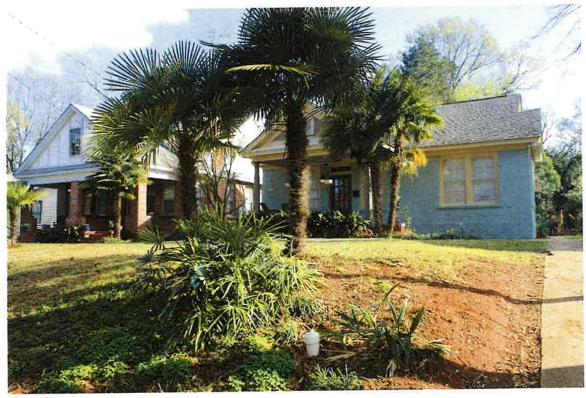
1810 Madison Avenue, Capitol Heights, north façade, and context shot with unpainted brick next door, 03/04/24

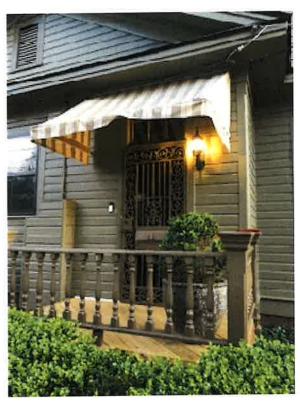
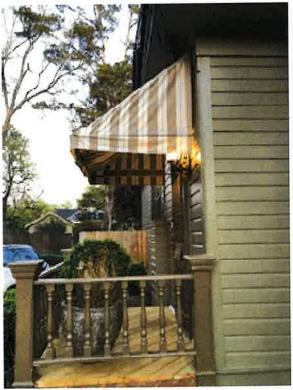
**REMARKS:** Mrs. Cumbie is requesting permission to alter the existing fabric awning on the north side of her residence to a wood frame awning. The current fabric awning requires periodic replacement. Frequent replacement is becoming too expensive, so Mrs. Cumbie would like to install a more solid awning that does not need to be replaced so often. The wood frame will be painted to match the color of the residence and it will have a shed roof to be clad in asphalt shingles matching the residence's main roof. The proposed wood frame structure maintains the same dimensions—5' x 4'—as the existing fabric awning.

2203 Felder Terrace, Old Cloverdale, current fabric awning, 03/28/24

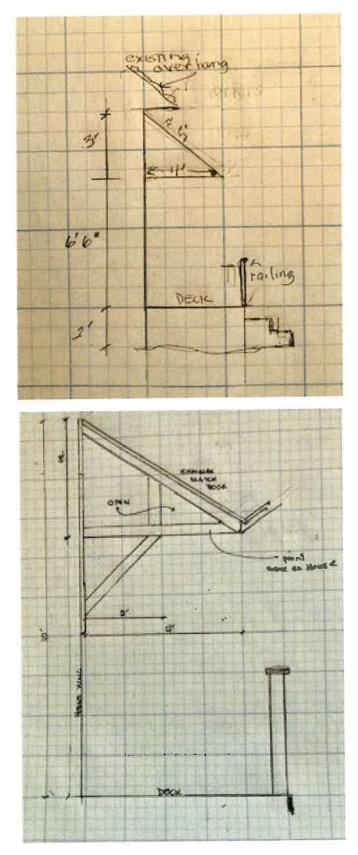
2203 Felder Terrace, Old Cloverdale, Awning dimensions and drawing, 03/28/24

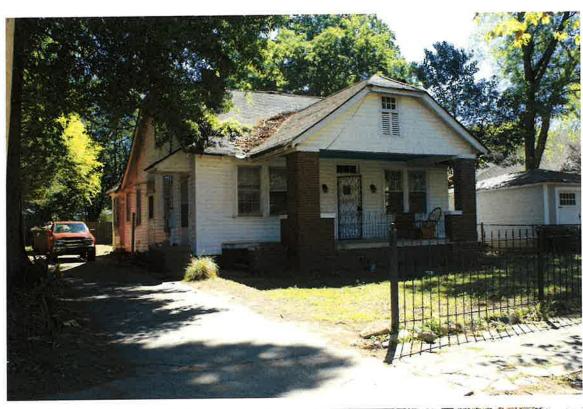
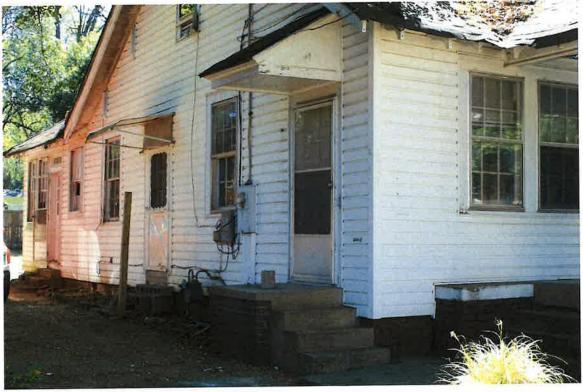
1717 S. Hull Street, Garden District, east façade and three doors to be removed on north elevation, 04/04/24

- Will the stairs/cinder blocks in front of each door be removed?
- What about the awnings above two of the doors?
- No objection, staff recommend approval of both items.

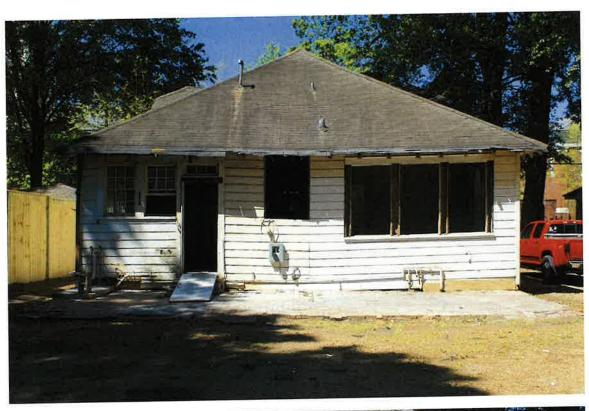
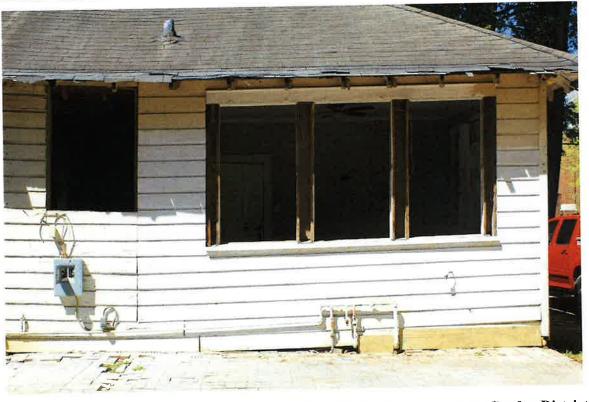
1717 S. Hull Street, east (rear) elevation and detail of rough window openings, Garden District, 04/04/24
